**DECLARATION OF ELIZABETH SUMMERER IN SUPPORT OF
RESPONSE OF CATELLUS OPERATING LIMITED
PARTNERSHIP TO LIQUIDATING TRUSTEE'S
SEVENTEENTH OMNIBUS OBJECTION
TO LANDLORD CLAIMS
(Claim No. 12328)**

2008 ROOF EVALUATION SURVEY

Project:
Industry Distribution Center #6
LAX01506 – 501 S. Cheryl Lane
City of Industry, CA

ROOF EVALUATION SURVEY

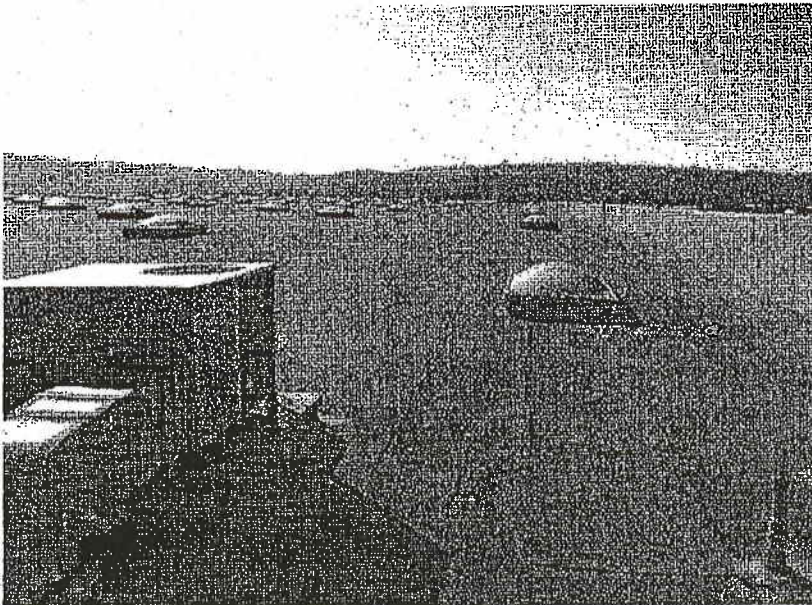
Photo #1 -- General overview of roof.

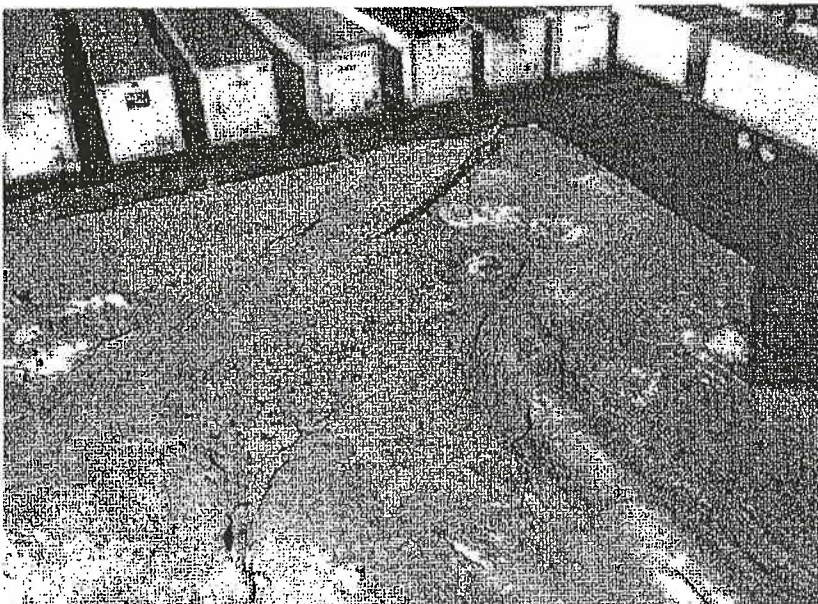
Deficiency: Splitting mastic on top of parapet walls at corner and panel joints.
Photo #: 2
Recommendation: Three-course with woven glass fabric embedded into and covered with flashing grade modified roof cement.

Photo #2 -- Splitting mastic at top of wall corner.

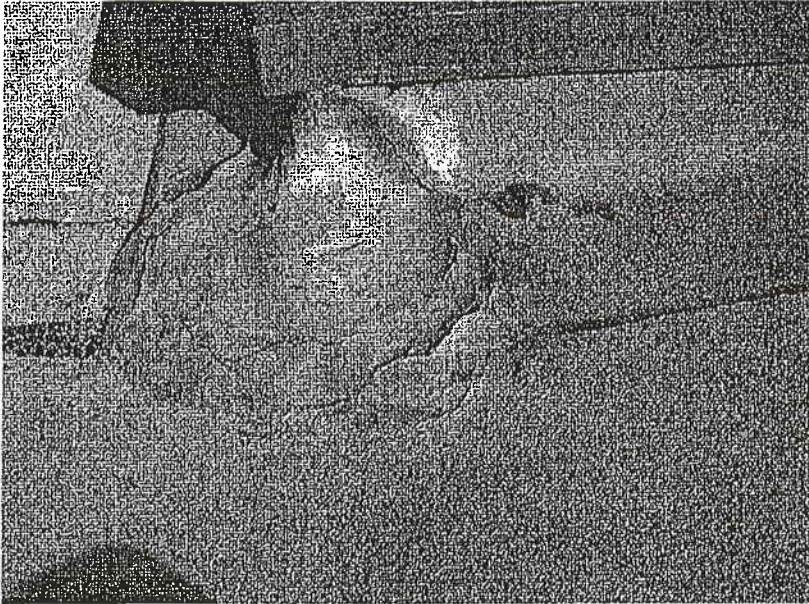
Deficiency: Splitting mastic at base flashing corners.
Photo #: 3
Recommendation: Monitor for potential leaks and repair as necessary until time of roof replacement.

Photo #3 – Splitting mastic at base flashing corner.

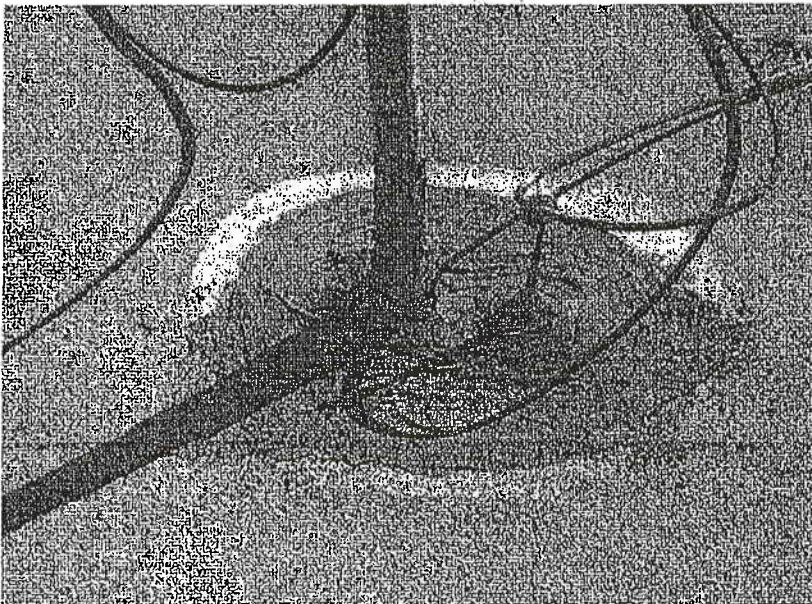
Deficiency: Splitting mastic at base of antenna support sitting on roof with no protection material.

Photo #4 – Splitting mastic at antenna pole resting on roof with no roof protection material.

Recommendation: Monitor for potential leaks and repair as necessary until time of roof replacement.

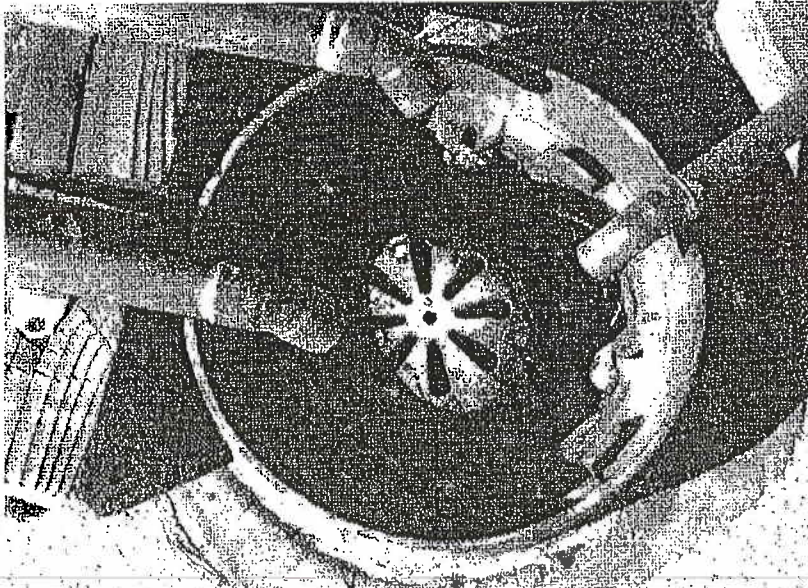
Deficiency: No bolts at condensate drain clamping ring.
Photo #: 5
Recommendation: Monitor for potential leaks and repair as necessary until time of roof replacement.

Photo #5 - Missing drain clamping ring bolts at condensate drain.

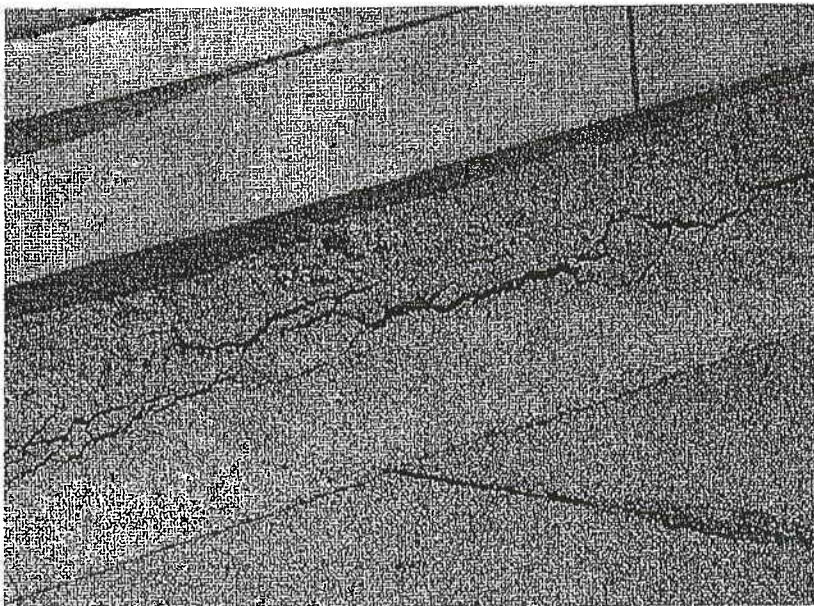
Deficiency: Mud cracking at SBS base flashings.
Photo #: 6
Recommendation: Monitor at this time.

Photo #6 - Mud cracking at SBS base flashing.

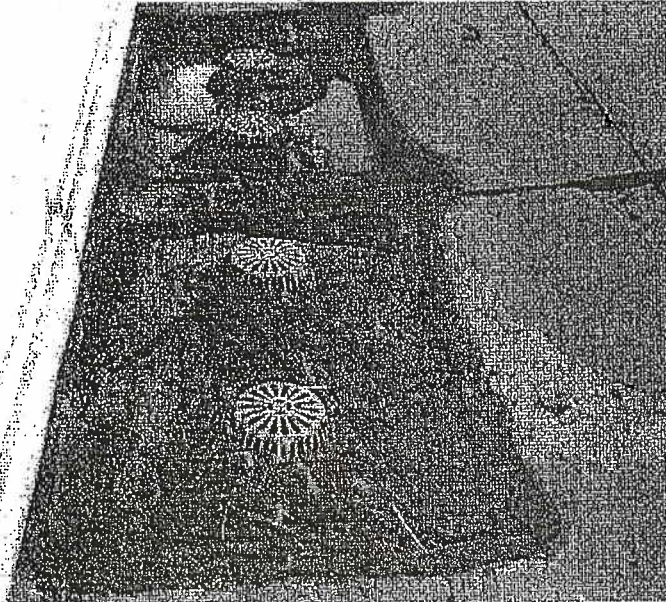
Deficiency: Leaves, excess loose granules, and debris in drain sumps are restricting proper drainage.

Photo #7 - Leaves, excess loose granules, and debris in drain sumps restricting proper drainage.

Recommendation: Remove all leaves, excess loose granules, and debris as often as necessary to ensure proper drainage.

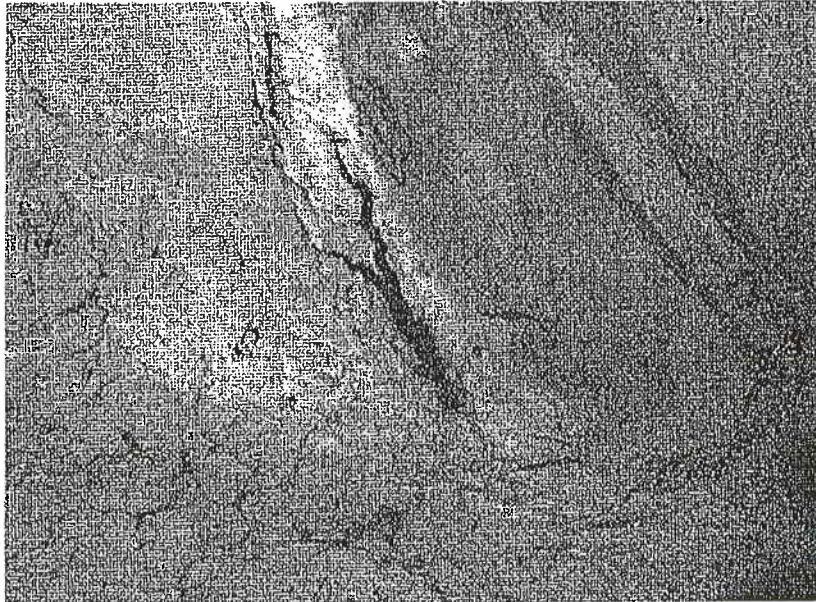
Deficiency: Splitting mastic at inside corner of scuppers.
Photo #: 8
Recommendation: Three-course with woven glass fabric embedded into and covered with flashing grade modified roof cement.

Photo #8 - Splitting mastic at inside scupper corner.
